THE THREE DISADVANTAGES CAUSED BY NOT CLEANING PHOTOVOLTAIC PANELS

Failure to Clean Photovoltaic Panels Can Lead to Several Disadvantages, Including:

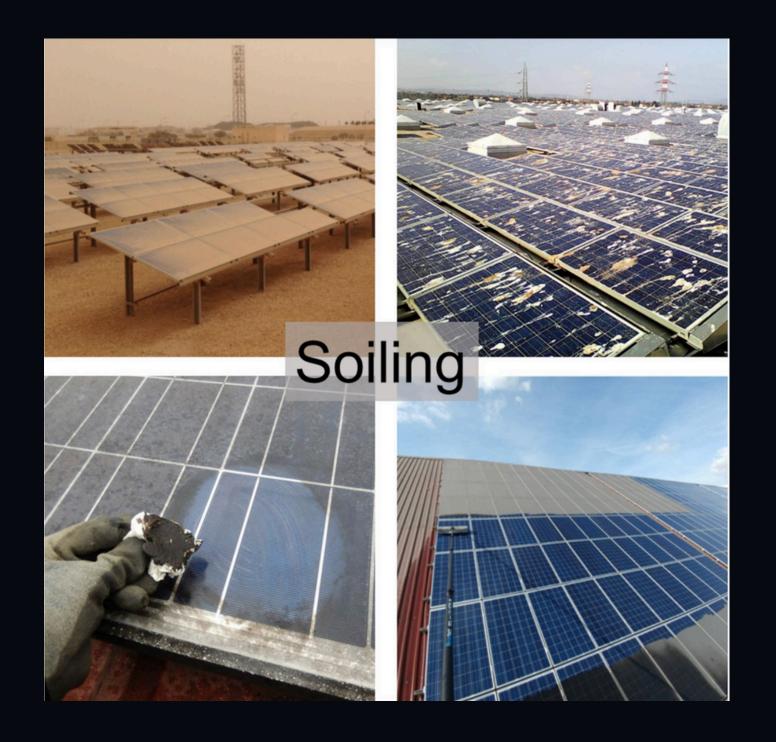
ABSENCE OF PROPER CLEANING OF THE PANELS

This photograph was taken at an agricultural plant company in Central California.

Cleaning is carried out by spraying water onto the panels from a truck every day. Visible calcium streaks have formed due to the use of hard water without filtration.

These panels have only been installed for two years, and it is unlikely they will last more than two or three more years without causing serious damage to the modules and a significant drop in system performance.

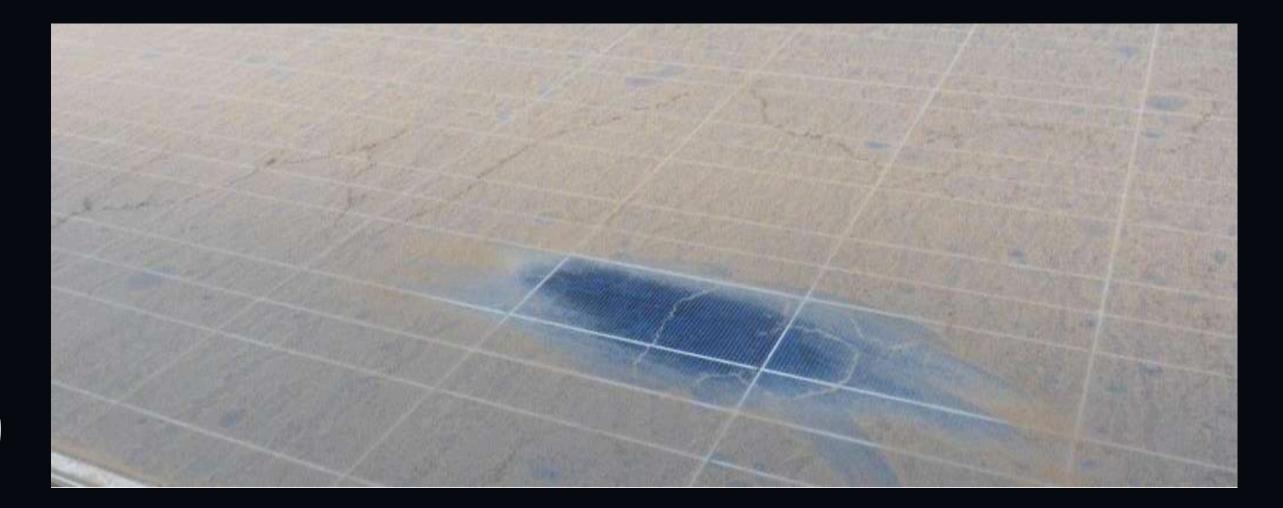
ABSENCE OF PROPER PANEL CLEANING

A photograph taken at a food production facility in Germany.

There are numerous bird droppings that have never been removed.

As a result, there is a significant loss in performance due to the lack of frequent cleaning.

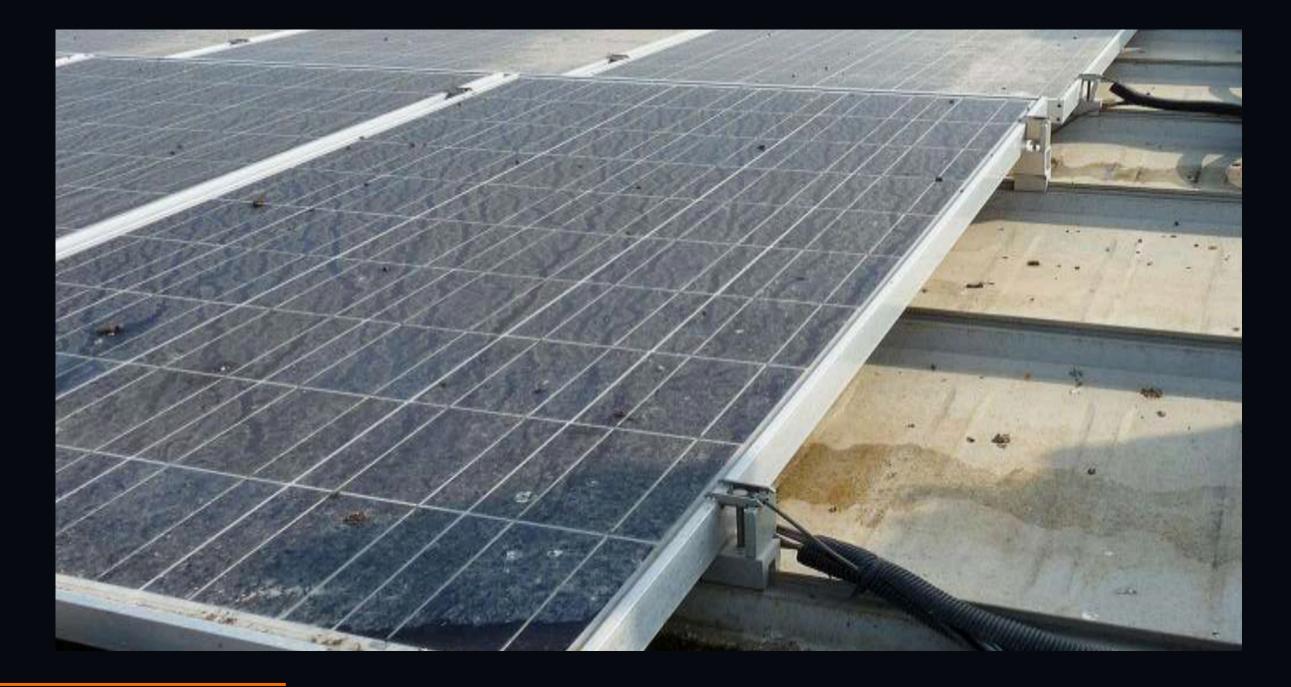
LACK OF PROPER SOLAR PANEL CLEANING

On the surface of these rooftop panels, installed at an animal feed production facility, you can see residues of pork rind mixed with seagull droppings.

These residues have settled on the panels and, primarily due to heat exposure, have turned into hardened encrustations that are very difficult to remove.

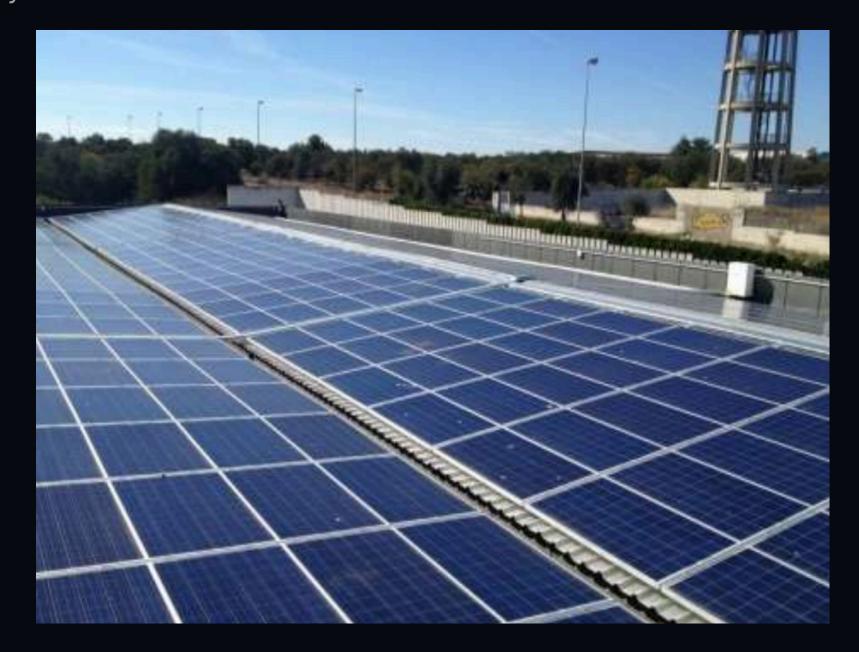
LACK OF PROPER SOLAR PANEL CLEANING

Greenhouse with Photovoltaic System, Near the Sea.

Salt deposits are visible on the panels due to the proximity to the coast.
